Route 117 Review of Ownership Transfer

October 2014

I. INTRODUCTION

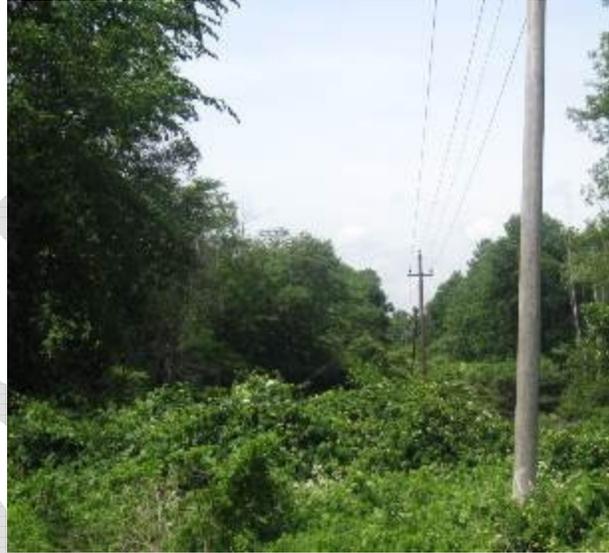
Utility poles at the Bolton Flats looking west

MassDOT has determined that the minimum setback for the utility poles from the roadway centerline is 23' (12' lane, 5' shoulder, 2' guardrail, 4' deflection zone). However, ideally the setback would be 26'. This would necessitate that many trees be clear cut to provide adequate space for the poles. If functional control of the corridor was to be transferred to the state, it is likely that in the interest of public safety that MassDOT would pursue removing many of the trees located near the roadway shoulder. The canopy of trees poses a safety hazard for traffic during snow and ice operations and increases the potential costs of roadway maintenance.

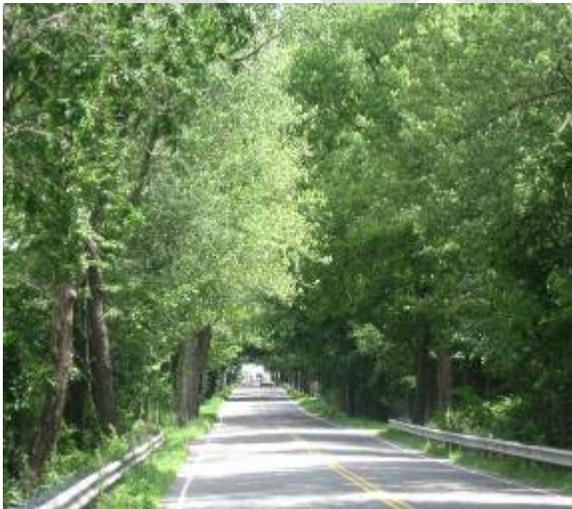
Canopy of trees over Rte. 117 at the Bolton Flats

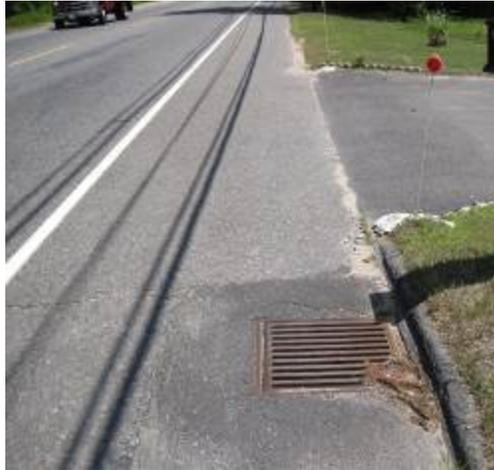
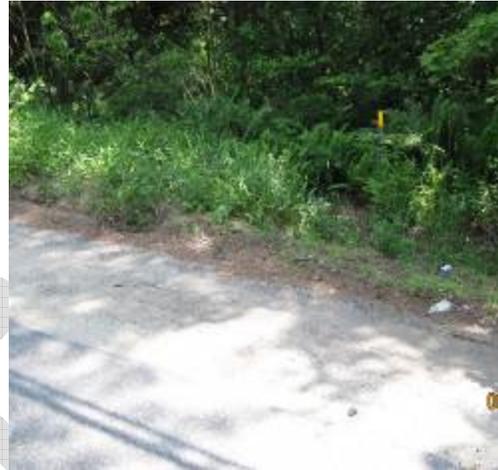
- Just east of the N. Main Street junction a catch basin was identified that suffers from intermittent blockage due to debris and sometimes floods over the roadway near the eastward outlet.

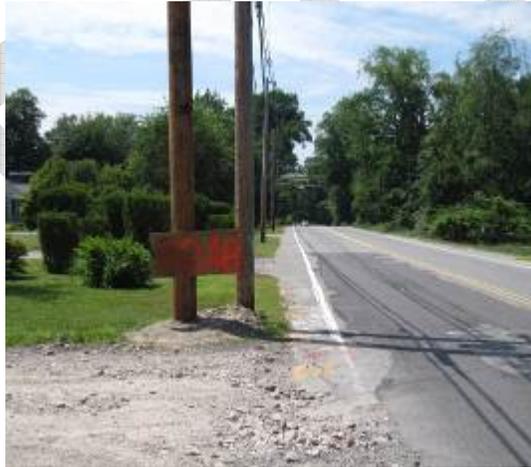
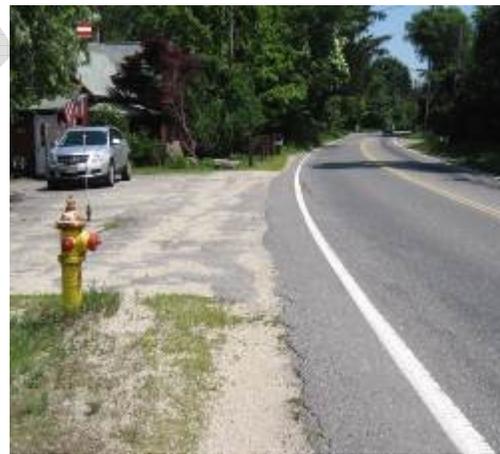
- Several utilities poles and some hydrants are located near the roadway and significantly limit shoulder widths. Additionally, it was acknowledged that gas and town water lines are present under the roadway.

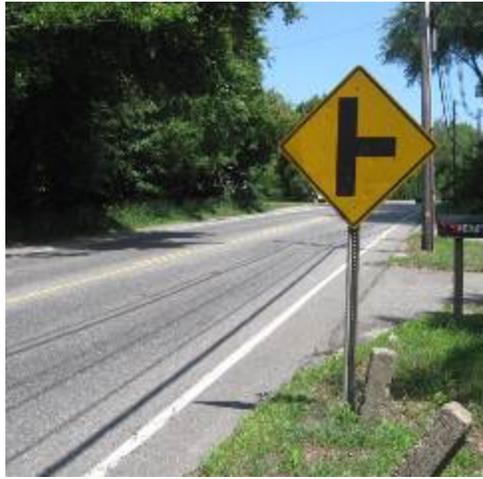
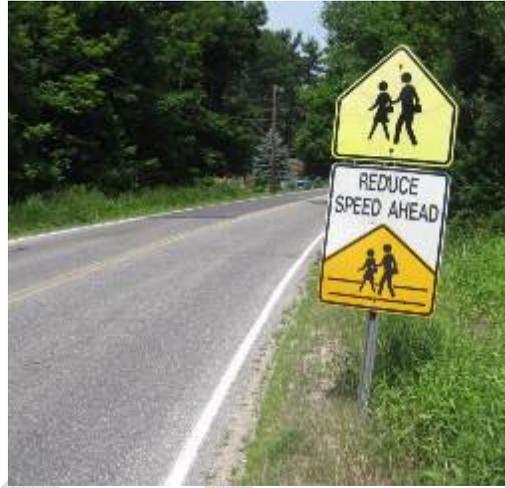
- Many of the traffic signs look worn with insufficient retroreflectivity and are set too low to the roadway (< 7') and too close to the shoulder edge (< 4'). These signs would need to be replaced and/or adjusted to be in compliance with MassDOT standards.

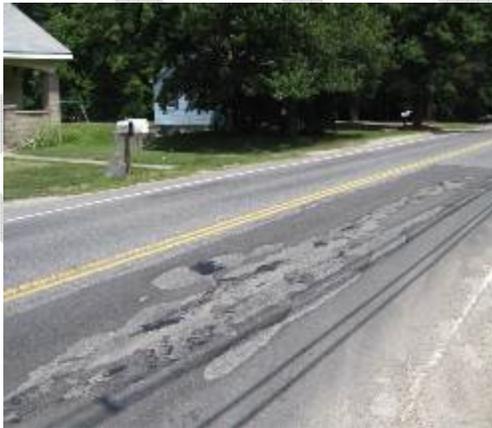
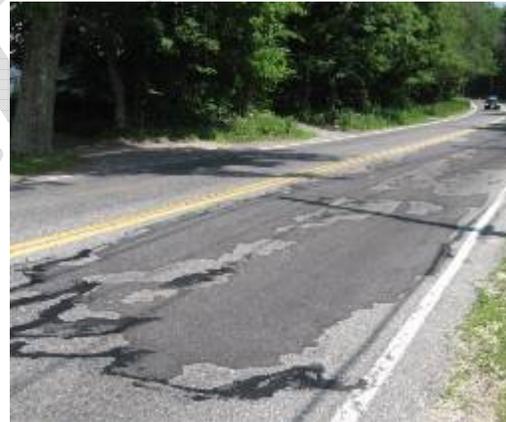
- Sections of the pavement overlays used to repair rutted pavement areas west of the Rte. 70 junction at Lunenburg Rd. and east of the Rte. 117/70 split show signs of unraveling and are in fair condition. It was expressed that approximately 12" of pavement is present in these areas.

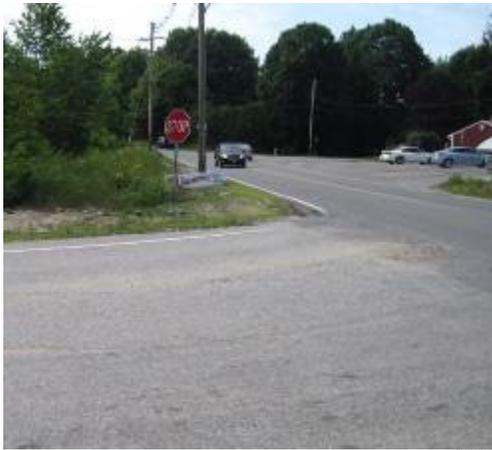
Langen Rd. looking west

- The sight distance for some of the minor roads that enter onto Rte. 117 were less than adequate.

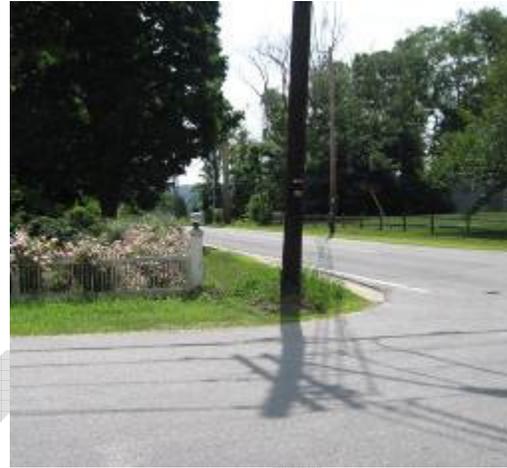
Harvard Rd. southbound approach looking east

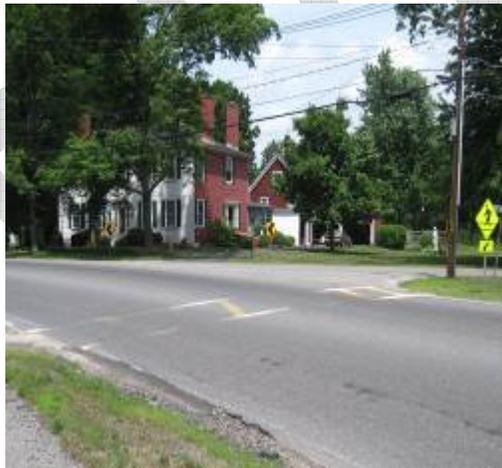
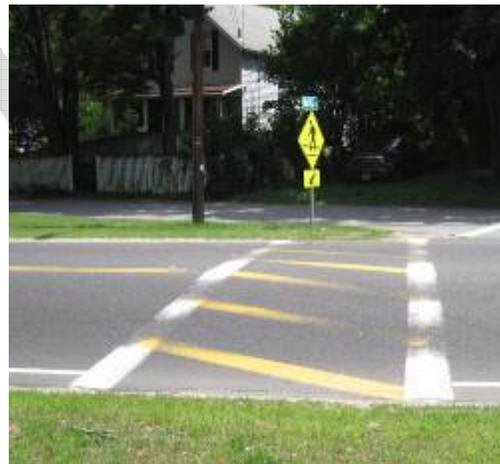
- There are three (3) noncompliant crosswalks in the Rte. 117/70 overlap. The crosswalks do not have wheelchair ramps and are disconnected from the sidewalks. Sidewalks were mostly located throughout the Rte. 117/70 overlap along the eastbound side of the road.

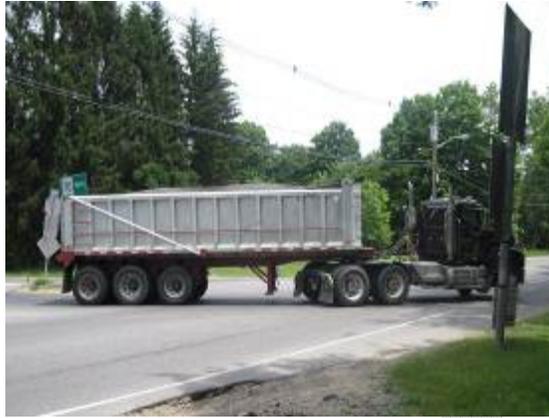
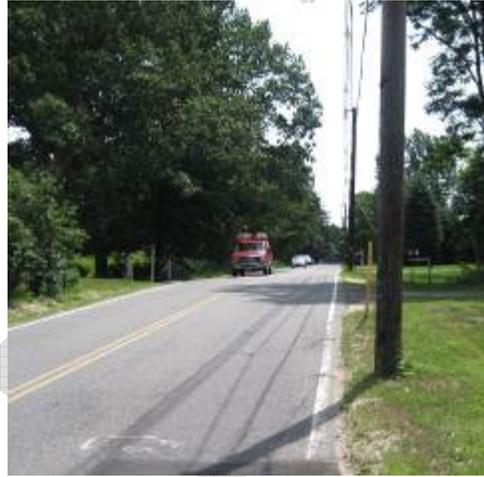
- High volumes of heavy truck traffic were witnessed on the Rte. 117/70 overlap moving eastbound. Just east of the Rte. 117/70 split some of the utility poles are setback a few feet from the roadway edge reducing the travel lane width. The average truck volume counts measured along Rte. 117 in the September 2013 MRPC Corridor Profile report was 5.03%. This was higher than the most recent MassDOT historical data.

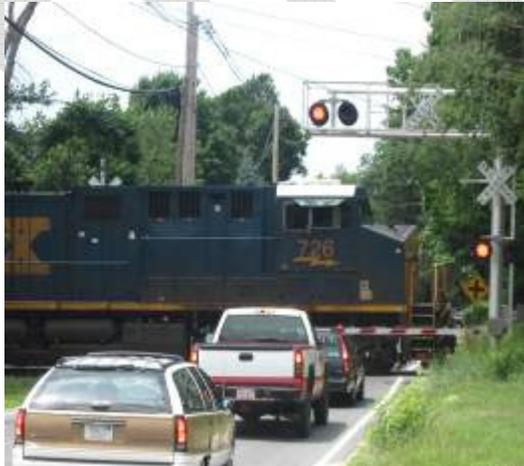
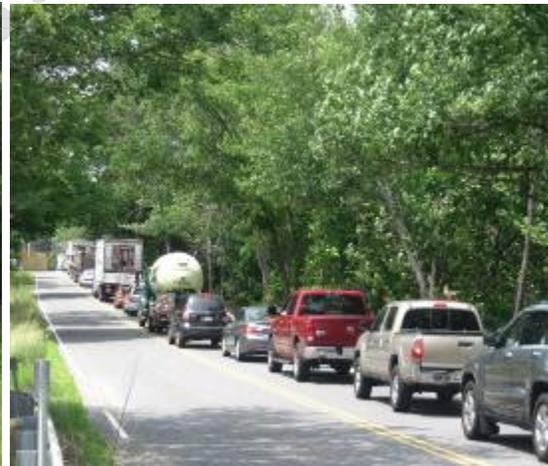
- A freight railroad crossing (Pan Am) exists just east of Harvard Rd. and may contribute to traffic congestion during peak hours.

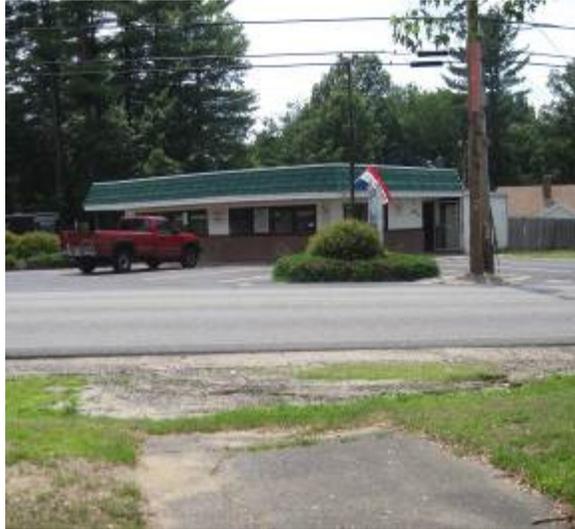
- Interest has been expressed by town residents for the construction of a pedestrian crosswalk from the Nashoba Regional High School to the Classic Pizza shop located just west of Forbush Mill Road. The speed limit of 45 mph through this area is high and would need to be reevaluated.

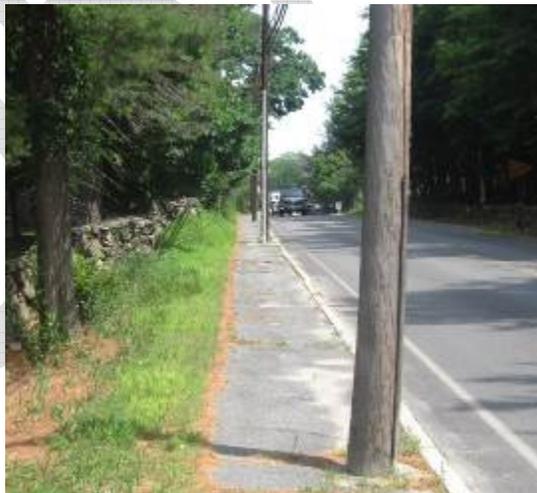
- Pedestrian sidewalks are present along the westbound lane near Ponside Dr., as well as, from Harvard Rd. to the Bolton Office Park. Much of the existing sidewalks contain obstructions from utilities and residential posted mailboxes and are not in conformance with MassDOT standards.

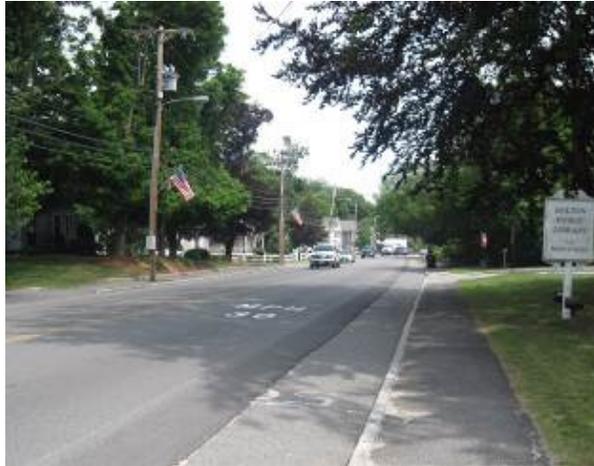
- Roadway shoulder width between the Bolton Public Library and the Bolton Town Hall looks adequate to support bicycle traffic.

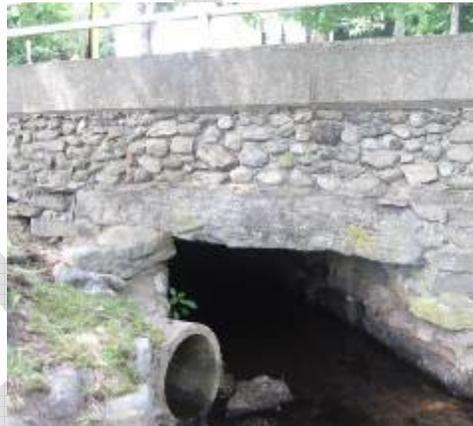
- An old stone box culvert is present just east of Mechanic Street at Pond Park.

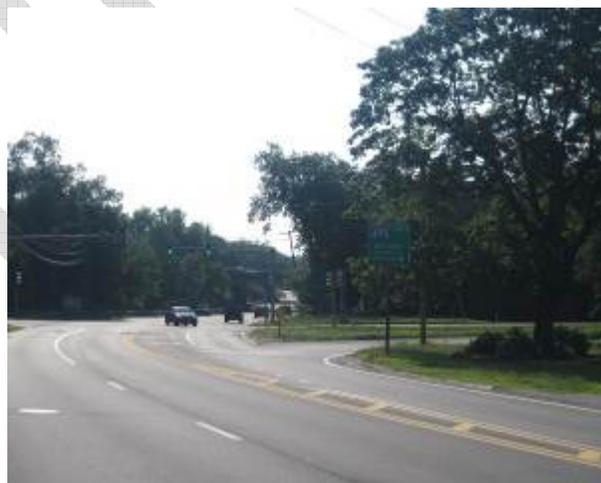
I-495 Southbound ramp

- There is a potential need to add a dedicated right turn lane to I-495 South to mitigate queuing issues for eastbound traffic at the I-495 interchange.

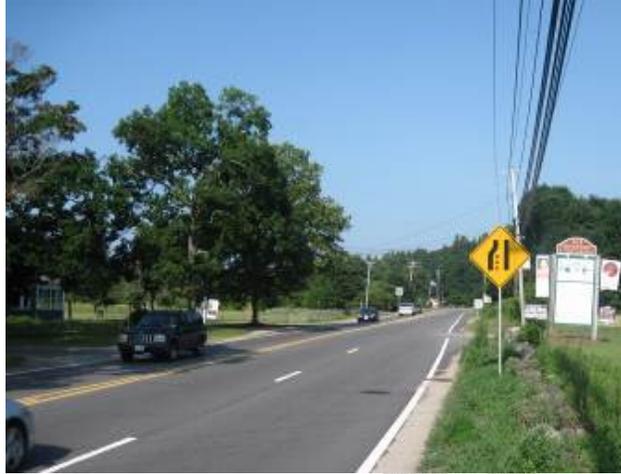
- The lane merge sign just past the I-495 interchange moving westbound could be moved further eastward to allow earlier notification to traffic.

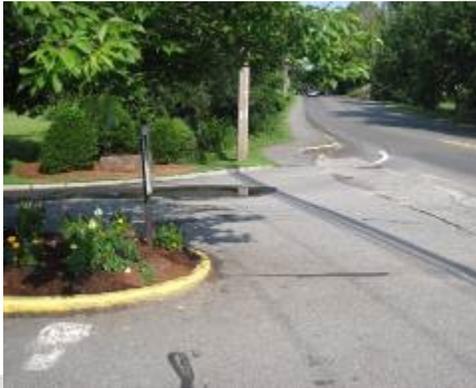
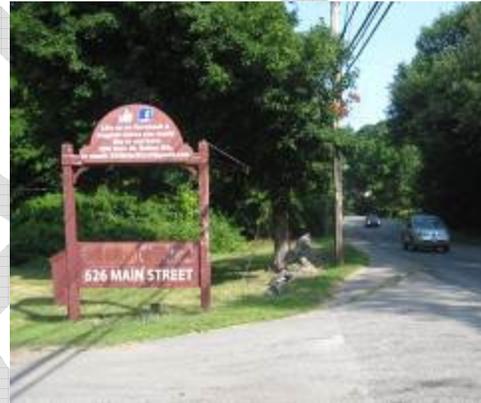
Exiting Bolton Office Park looking west

Exiting the Salt Box shops looking west

- Left turning movements coming from Bolton Office Park and The Salt Box shops experience high delays and may need improvements.

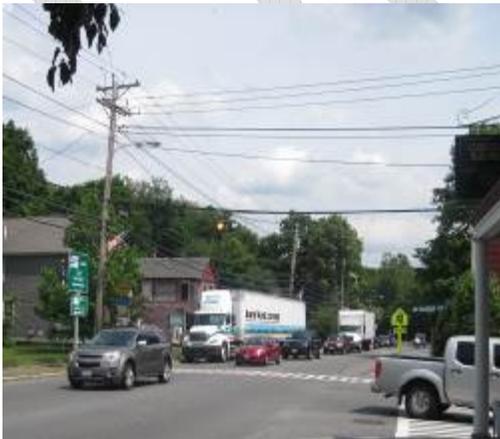
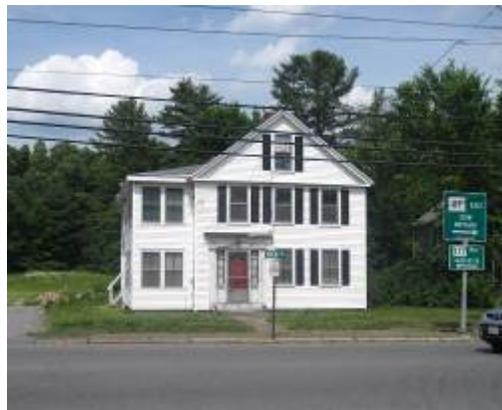
- Wattaquodock Hill Rd. intersection may require a traffic signal system or other capacity improvement to address heavy traffic flow. An historic structure located on Rte. 117 westbound provides a constraint to widening.

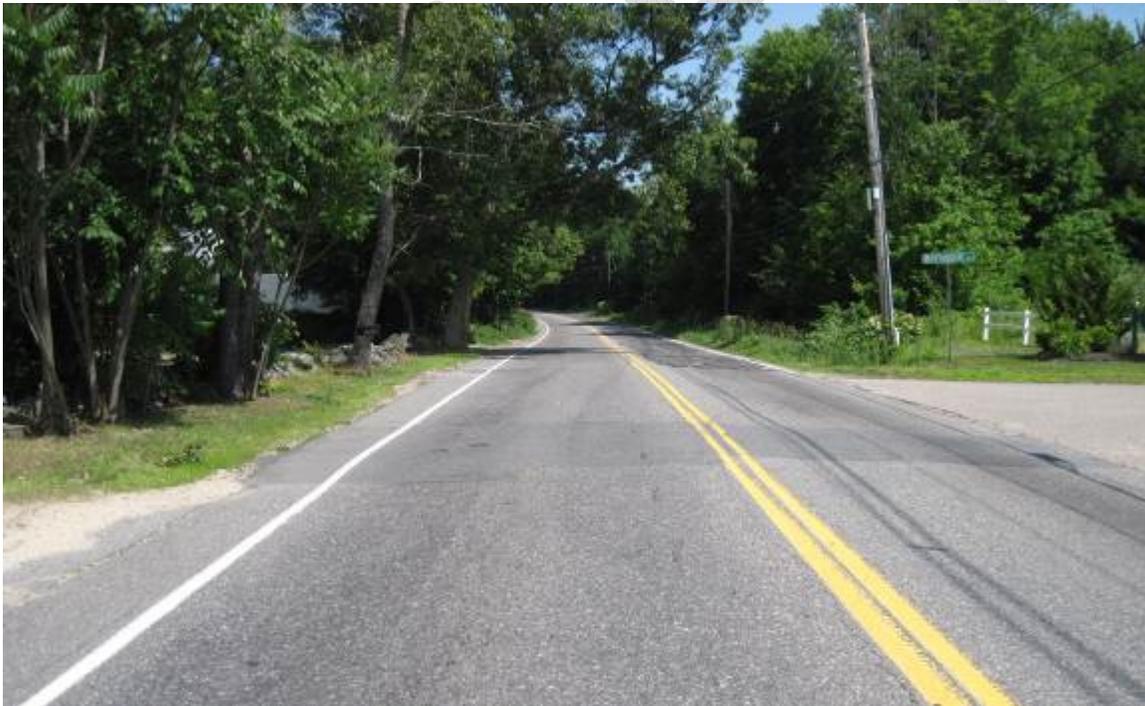
Looking east towards Devonshire Way

- All areas of the corridor where 4" wide pavement marking exists would be restriped with 6" pavement markings.

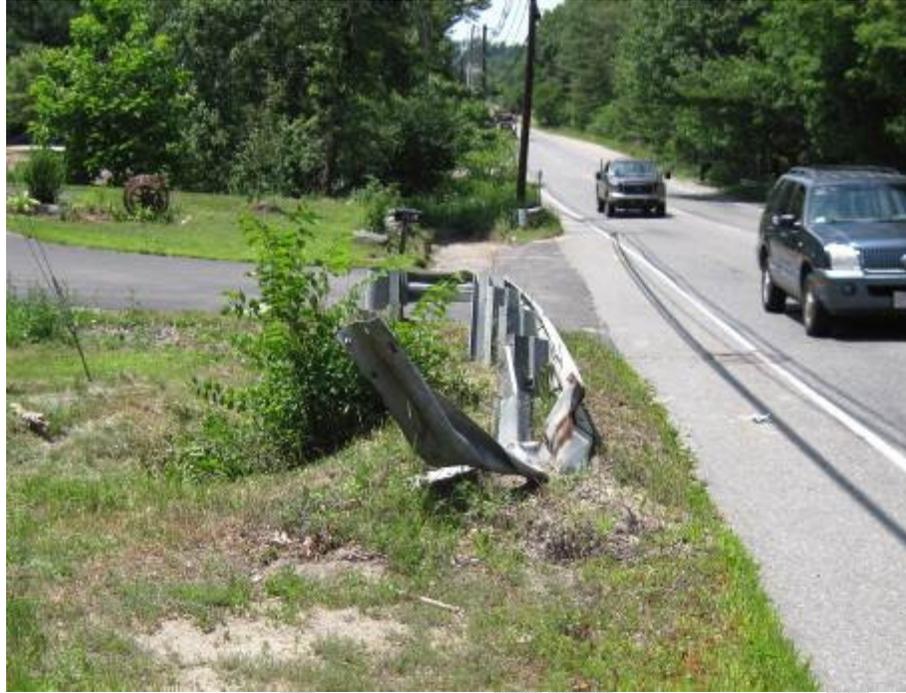
Rte. 117 east of I-190 interchange

- Upgrades to guardrail and guardrail end treatments would be performed.

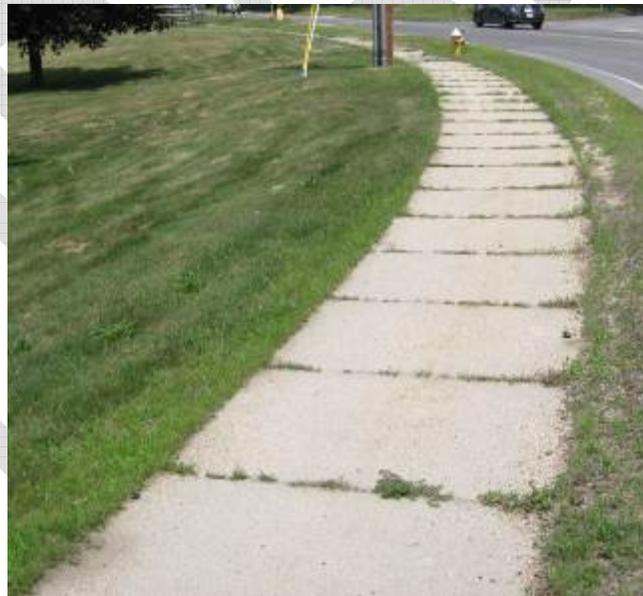
Sidewalk in front of Luther Burbank Middle School

- Americans with Disabilities Act (ADA) compliance issues with wheelchair ramps, crosswalks, and sidewalks would be addressed. Specifically repair and reconstruction of sidewalk in front of Luther Burbank Middle School in Lancaster which has considerable vegetation growth.

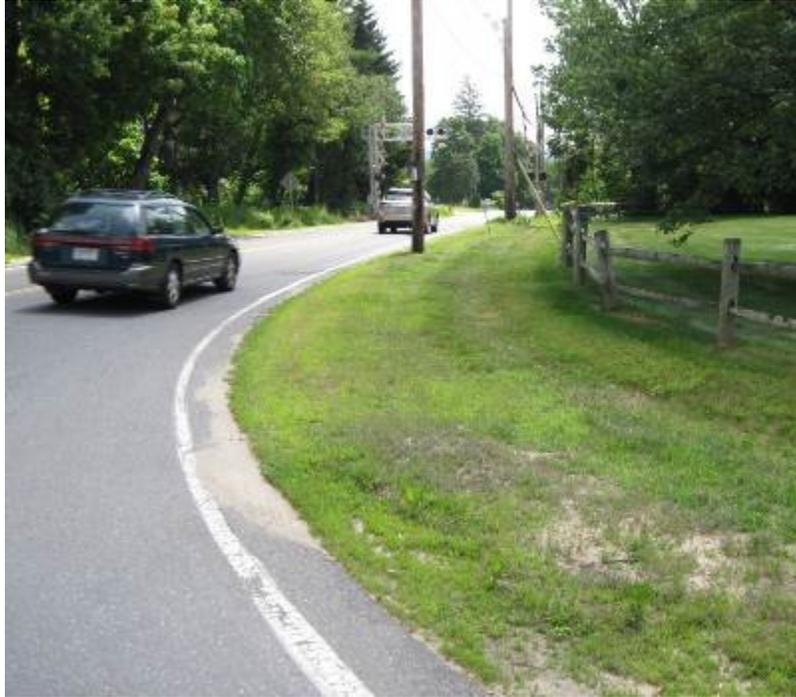
Poor site distance looking east from Harvard Road (North)

- Sight Distances at intersections would be evaluate and improved.

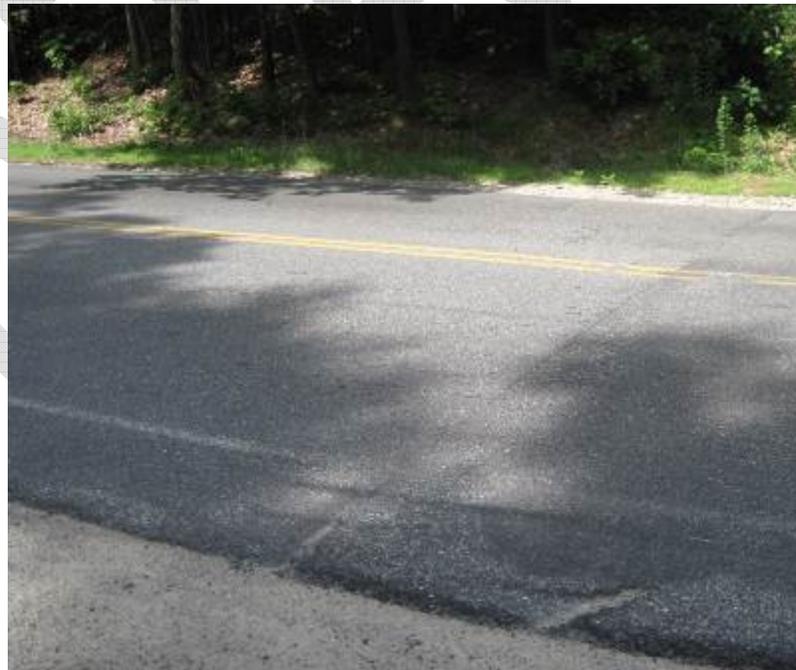
Rte. 117 just east of Nashoba Regional High School

- All areas of the corridor where 4" wide pavement marking exists would be restriped with 6" pavement markings.

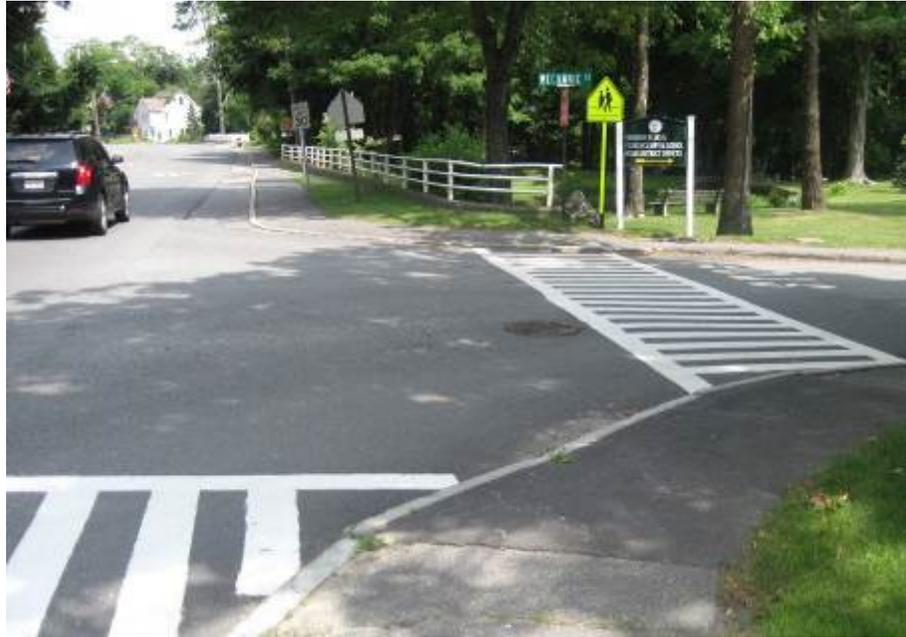
Missing crosswalk curb cut & wheelchair ramp at Mechanic Street.

- Americans with Disabilities Act (ADA) compliance issues with wheelchair ramps, crosswalks, and sidewalks would be addressed.

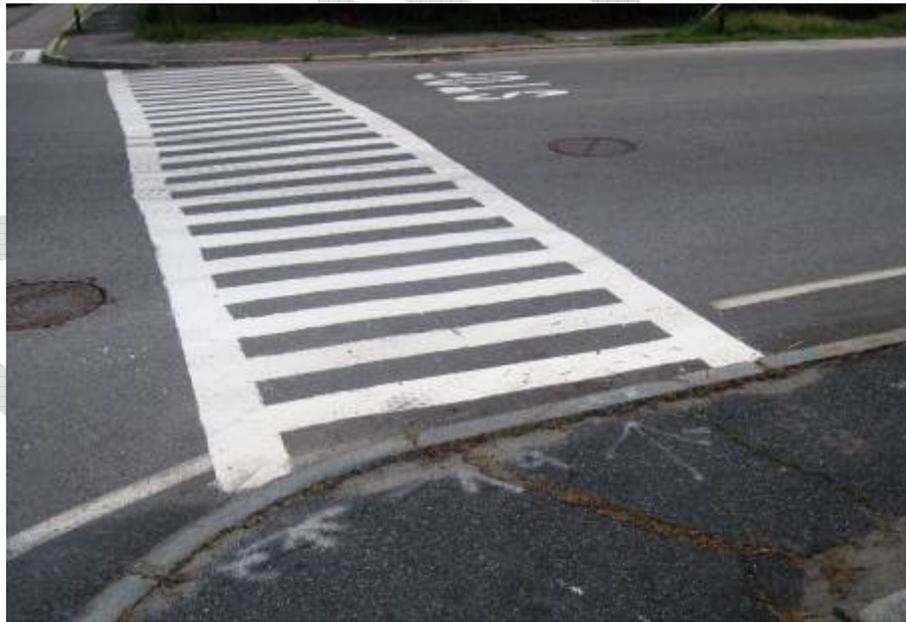
Missing crosswalk curb cut & wheelchair ramp at Wattaquodock Hill Road.

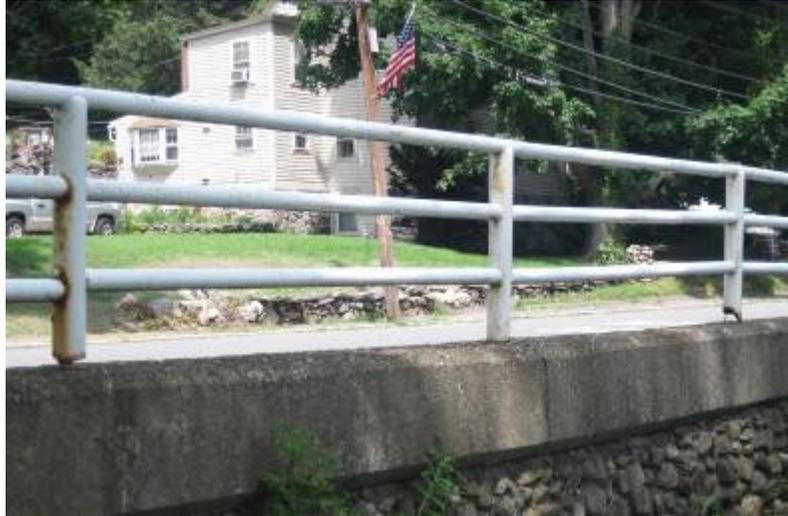
- The damaged metal railing along concrete wall at Pond Park next to Mechanic St. would be replaced and upgraded. Currently several of the railing posts are corroded at their base to a point where they are disconnected from the wall. These posts are effectively providing no support and pose a safety hazard to pedestrians and vehicular collisions.
- Upgrades to guardrail and guardrail end treatments would be performed.
- Sight Distances at intersections would be evaluate and improved.

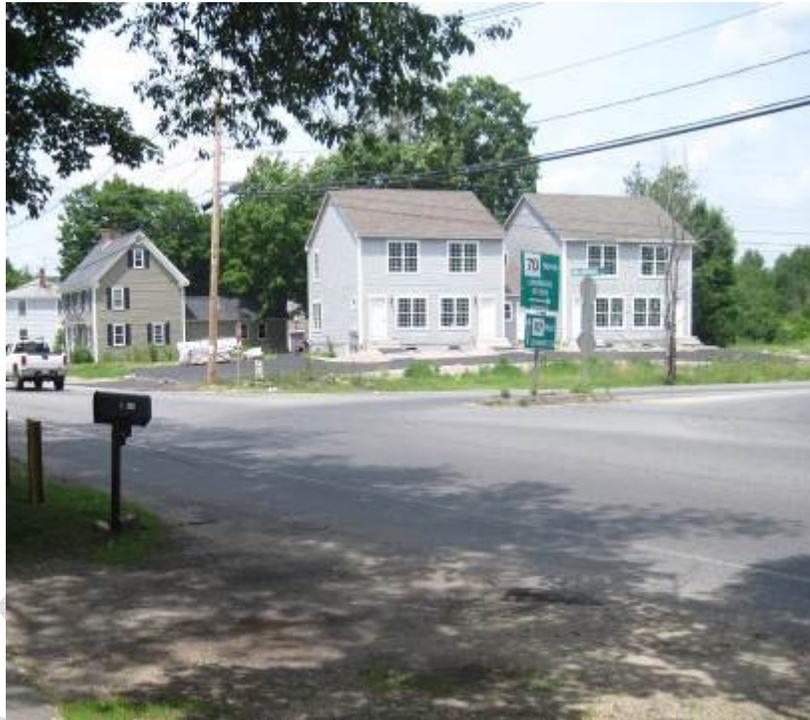
Rte. 117 (Main Street)/ Rte. 70 (Lunenburg Road) Intersection

- Based on the MRPC 2013 corridor profile, the unsignalized intersection of Main Street (Rte. 117/70) and Rt. 70 (Lunenburg Rd.) has been classified as a high crash location. The crash analysis from 6/22/09 to 9/22/10 found that 23 crashes occurred at the intersection, with the southbound direction seeing the highest percentage of crashes at 78%. Both the AM and PM peak hour level of service (LOS) values for the southbound approach on Lunenburg Rd. for left-turning traffic were (F), indicating high delays. Furthermore, the intersection satisfies four Manual on Uniform Traffic Control Devices (MUTCD) signal warrants: Warrant 1, Eight-Hour Vehicular Volume, Warrant 2, Four-Hour Vehicular Volume; Warrant 3, Peak Hour; and Warrant 8, Roadway Network. It is under these conditions that MassDOT recognizes that major safety and traffic flow improvements are needed for the intersection. Viable solutions to achieve this would be the construction of a roundabout or installation of a traffic signal system.

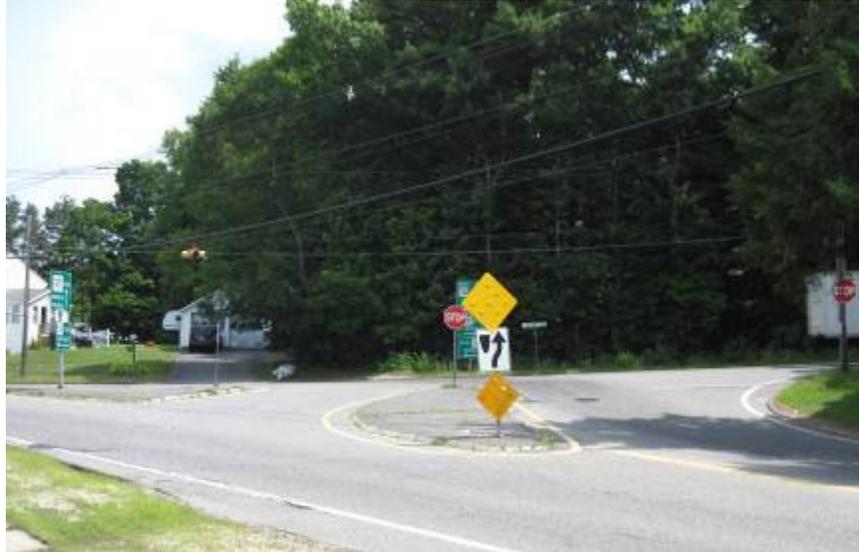
Intersection of Main St./Seven Bridge Rd. (Rte. 117/70) and Main St. (Rte. 70)

- The skewed intersection of Seven Bridge Road (Rte. 117) at Main Street (Rt. 70) contains east and westbound approaches that are primarily uncontrolled excepted for a single flashing yellow light and a channelized eastbound right-turn, and the

northbound approach is stop-controlled with a flashing red light and a channelized right-turn. The 2013 MRPC Corridor Profile report designated this intersection a high crash location. The crash analysis from 7/30/10 to 5/20/13 found that 15 crashes occurred at the intersection, with the northbound approach seeing the highest percentage of crashes at 73%. Both the AM and PM peak hour LOS for the left/right Rte. 70 northbound approaches were (F), indicating high delays. The intersection also satisfies four MUTCD signal warrants: 1,2,3,

and 8. Additionally, there is inadequate sight distance available for the northbound approach looking eastward, as private bushes and trees block the line of sight. It is under these conditions that MassDOT recognizes that safety and traffic flow improvements are needed for the intersection and would likely pursue the construction of a roundabout or the installation of a traffic signal system to address these concerns. A minor profile adjustment may also be required to reduce the vertical alignment of the roadway just east of the intersection, improving sight distance and safety.

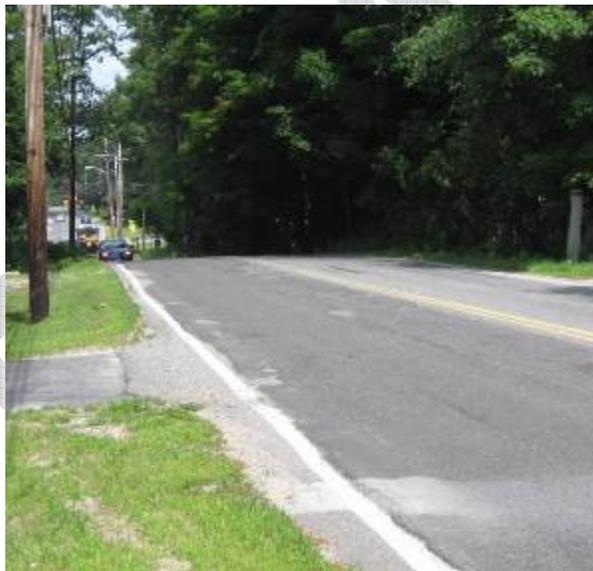
Profile crest east of Rte. 117/70 spilt

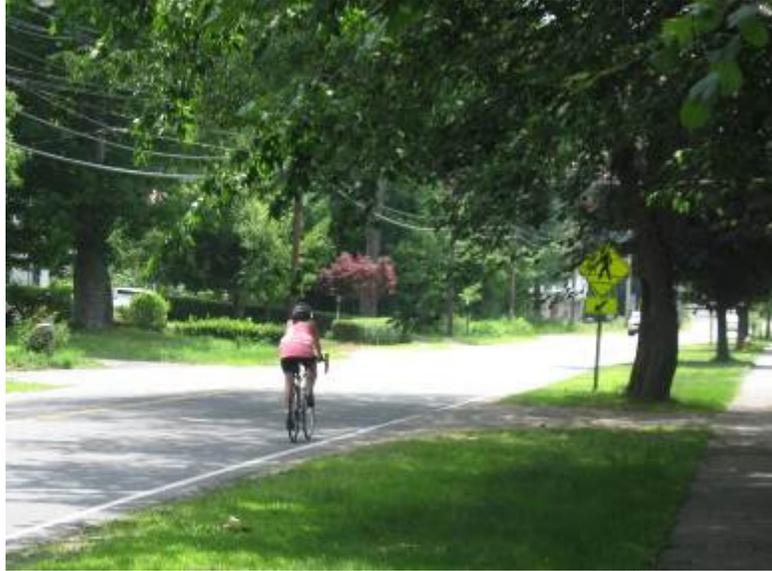
Bicyclist just east of the Rte. 70 and Rte. 117 intersection

- The typical cross section of the roadway along the Rte. 117 corridor has pavement widths of 24' and narrow to no shoulders. The lack of adequate shoulder clearance makes bicycle travel unsafe and discourages its use. One of the higher bicycle focused areas along the corridor is where Rte. 117/70 converge in

Lancaster. To accommodate safer multimodal traffic and sustainable transportation methods, MassDOT is inclined to take long term steps like roadway box widening at the most narrow sections of the bicycle focused areas. MassDOT would likely encourage 5' shoulders in both the eastbound and westbound directions in future project developments. Roadway widening would also likely be used to add additional space in some of the more constricted travel lanes found near the Bolton Flats region where narrow shoulders are present with high volumes of heavy truck traffic.

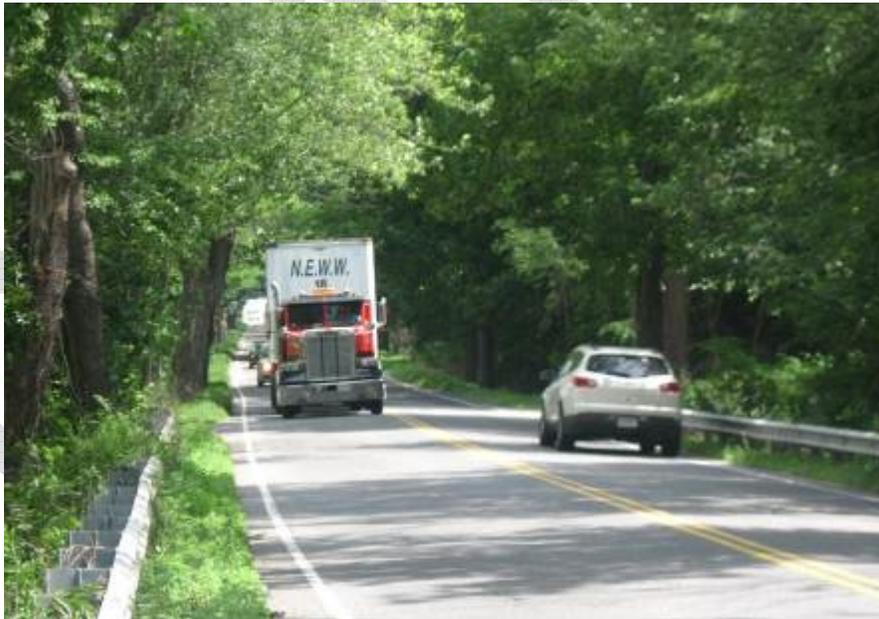
Heavy truck in Bolton Flat Section

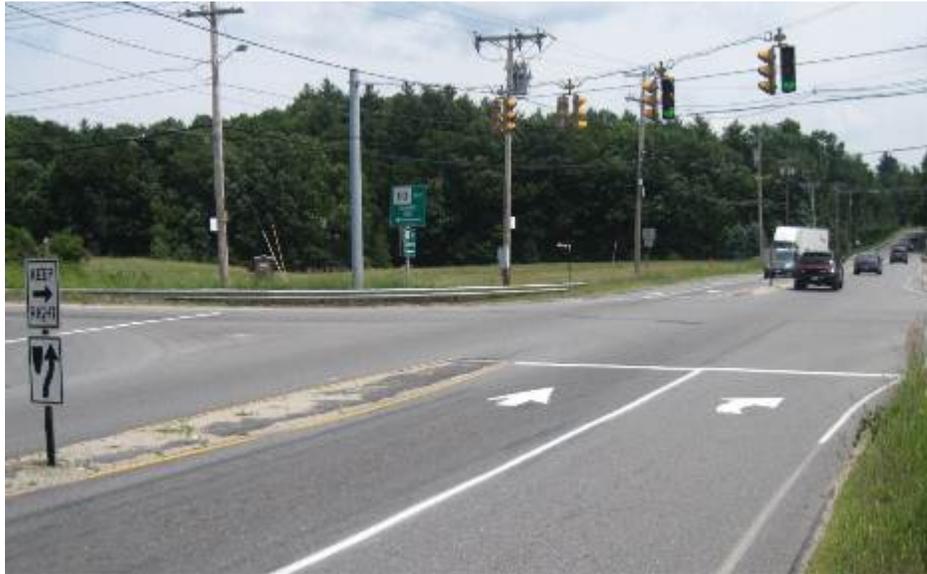
Narrow travel lanes at Still River Rd. intersection

- The intersection of Rte. 117 and Still River Rd (Rte. 110) in Bolton is a signalized intersection which sees heavy bicycle traffic coming from Rte. 110 and is adjacent a busy commercial store, Bolton Orchards. In spring 2014 MassDOT recorded a peak adjusted ADT count of approximately 2,600 vehicles for the north and southbound Rte. 110 approaches. The intersection traffic signal system is old and the travel lanes are narrow with minimal shoulder clearance available for bicycles.

MassDOT would likely address several of the intersection issues in efforts to improve traffic flow efficiency and safety for all traffic modes. Safety upgrades that would be needed involve complete reconstruction of the intersection. This

would include sidewalk connections, new signs, traffic signal system, and improved travel lanes. Moreover, MassDOT would look to move many of the access points to Bolton Orchards away from the intersection due to the increases in delays and potential crash hazards associated with turning entering/exiting traffic.

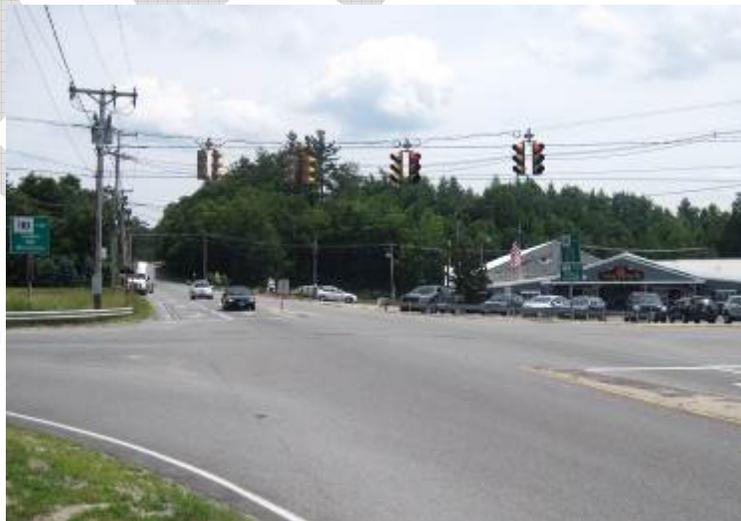
Bolton Orchards at Rt. 117 and Still River Rd. Intersection

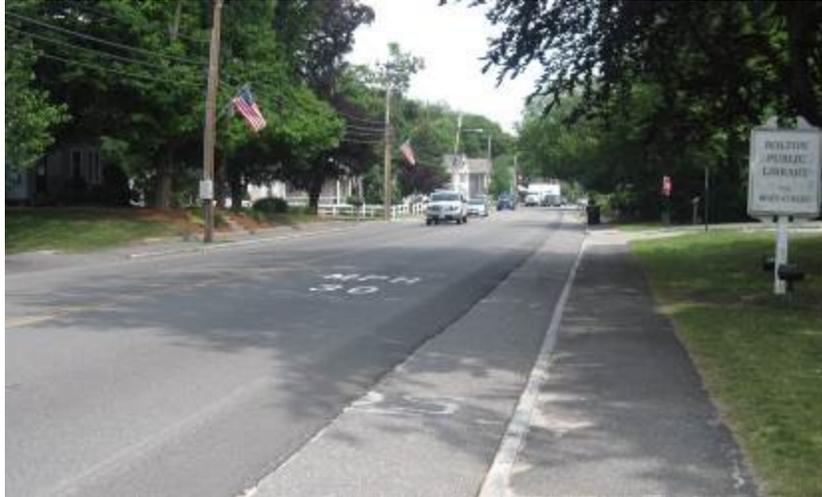
Wide roadway shoulders looking east at the Bolton Public Library

- The typical cross section of the roadway along the Rte. 117 corridor has pavement widths of 24' and narrow to no shoulders. The lack of adequate shoulder clearance makes bicycle travel unsafe and discourages its use. One of the higher bicycle focused areas along the corridor is from the Rte. 117/110 junction at Still River Road moving eastwards towards the Bolton Town Hall. To accommodate safer multimodal traffic and sustainable transportation methods, MassDOT is inclined to take long term steps like roadway box widening at the most narrow

sections of the bicycle focused areas. However, existing shoulders between the Bolton Library and the Town Hall may require less widening, as shoulder widths are increased in these locations. MassDOT would likely encourage 5' shoulders in both the eastbound and westbound directions in future project developments. This section in Bolton is presently used by some local residents to park their vehicles. On-street parking would be prohibited if control of Rte. 117 fell under state ownership. Roadway widening would also likely be used to add additional space in some of the more constricted travel lanes found near the Still River Rd. intersection of the corridor.

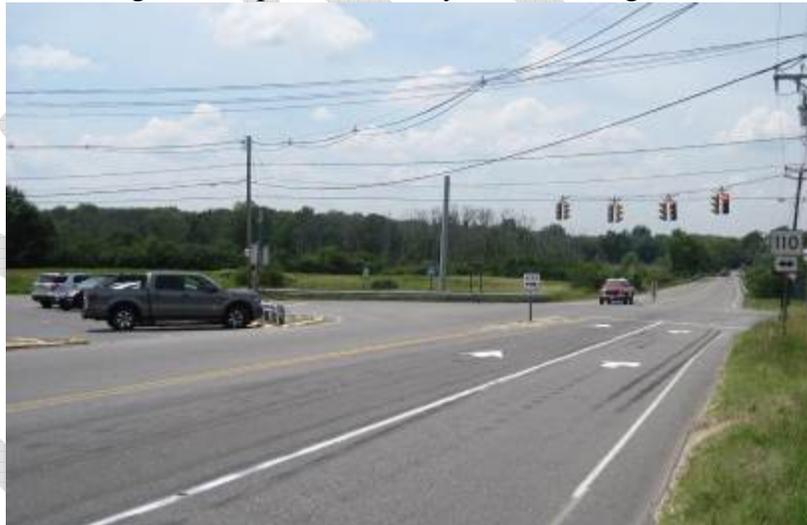
Narrow shoulders and travel lanes at Still River Rd. Intersection

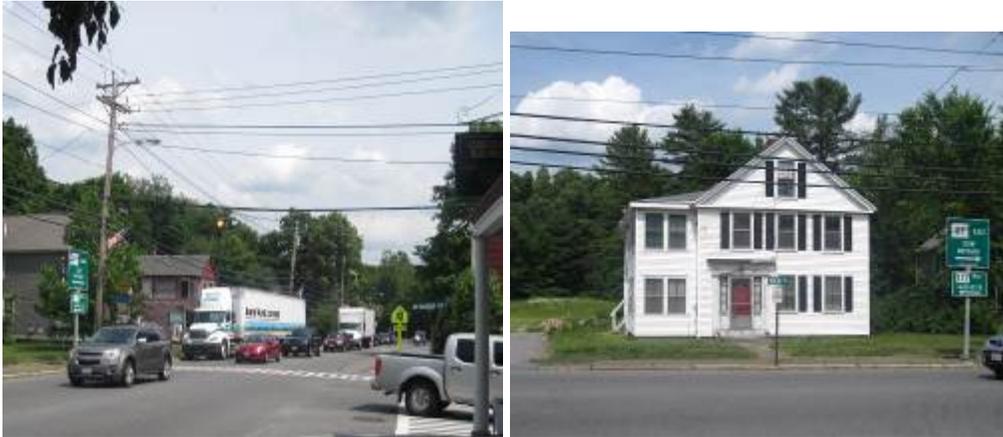
- The Rte. 117 intersection with Wattaquaddock Hill Rd. experiences significant delays in the peak hours. Traffic backups can extend as far I-495 along Rte. 117 and for over 1000 feet on Wattaquaddock Hill Rd. MassDOT is likely to widen both roadways to accommodate additional turning lanes at the intersection. The pavement widenings would also accommodate wider shoulders for bicyclists. Sidewalk would also be added. It is anticipated that structure takings would most likely be required.

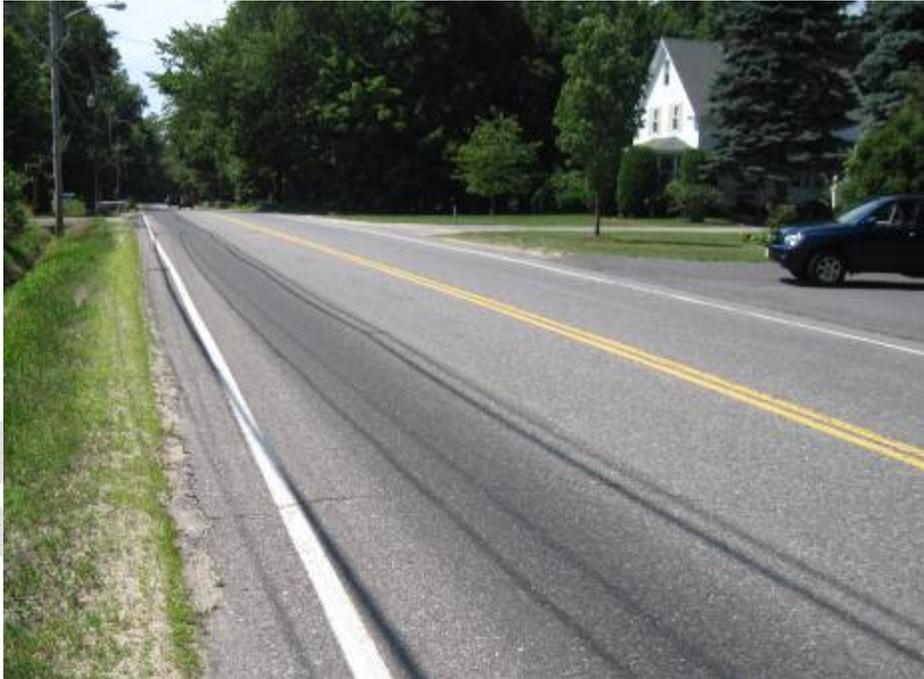
- Sections of pavement overlays in the western section of Rte. 117 in Lancaster show signs of unraveling and are in fair condition. Evidence of roadway rutting that has not been recently overlaid is also apparent (See above photo). Conversations with the town DPW have indicated that overlays have been applied over the years. There is an estimated 12" of pavement present in this location of the corridor.

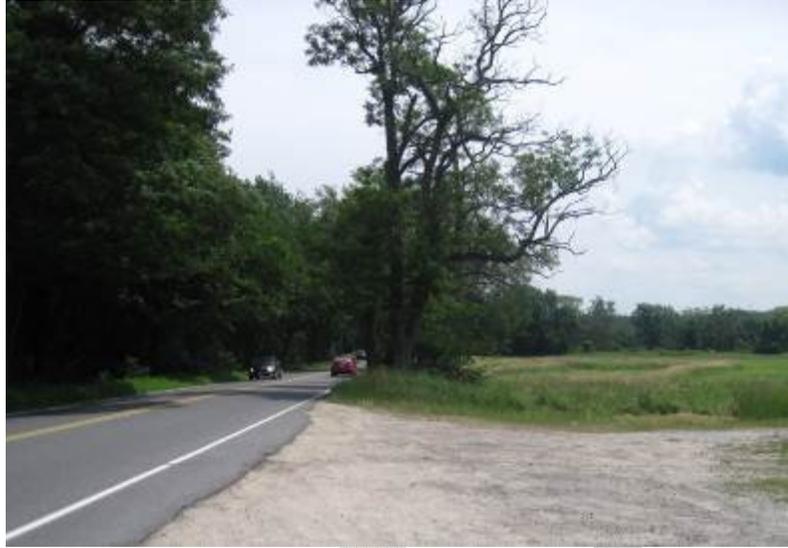
Bolton Flats located near Lancaster Fairgrounds entrance

- Drainage/flooding concerns around the Bolton Flats area have been raised by Committee participants for the Town of Lancaster. Major rain events and spring thaws have sometimes caused the Nashua River to flood in this area, causing the closure of Rte. 117. The 2013 MRPC Corridor Profile report acknowledges that raising the roadway through this section should be given strong consideration.

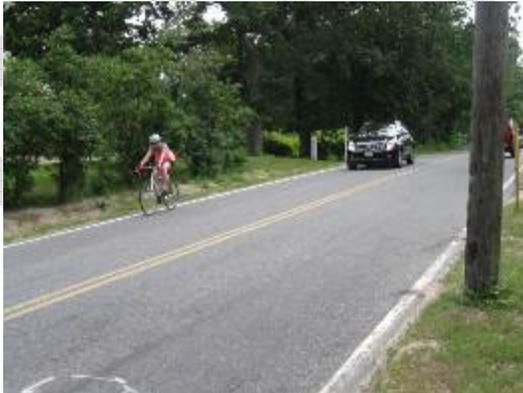
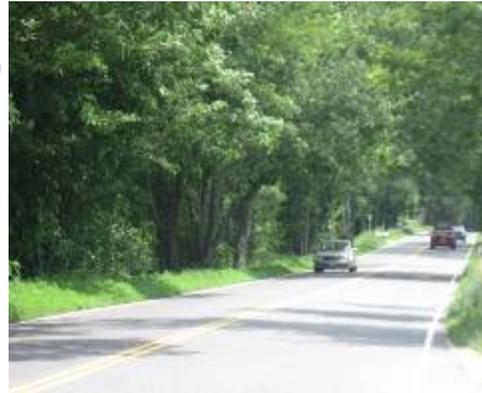
Rte. 117 just east of the Rte. 117/70 split

Rte. 117 thru Bolton Flats

- Additional signage to improve bicycle awareness especially in areas with no shoulders and limited ROW, such as the Bolton Flats area, should be considered.

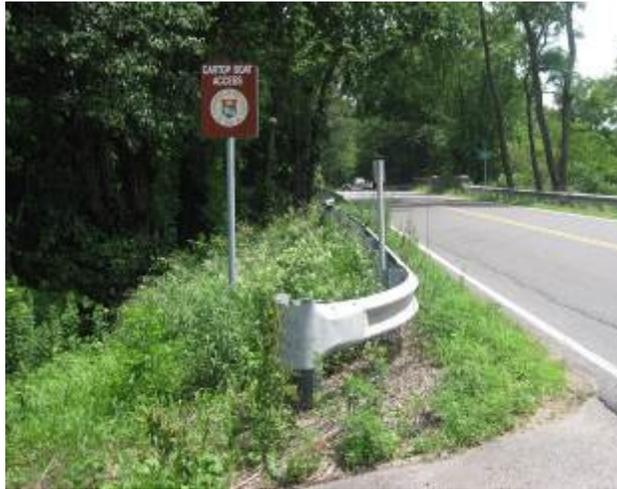
- The boat launch along the Nashua River in the Bolton Flats region of Lancaster has poor visibility due to a sloped driveway and vegetation growth. Crash hazards are magnified due to increased potential for turning vehicles towing trailers.

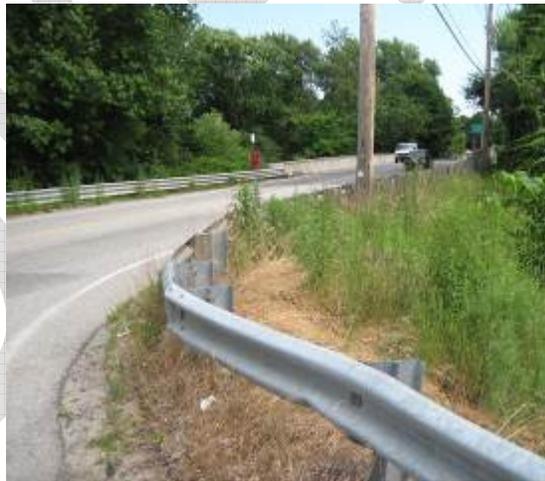
Langen Rd. approach looking east

- The Langen Rd. intersection is a potential high crash location with 13 crashes between 2/15/10 and 11/20/12, and a MRPC Equivalent Property Damage Only (EPDO) point total of 25. The intersection is approximately 1,800' to the west of the Rte. 117 (Main St.) and Rte. 70 (Lunenburg Rd.) intersection. Drivers can anticipate a LOS of (E) entering Rte. 117 from Langen Rd. in the PM peak hour.

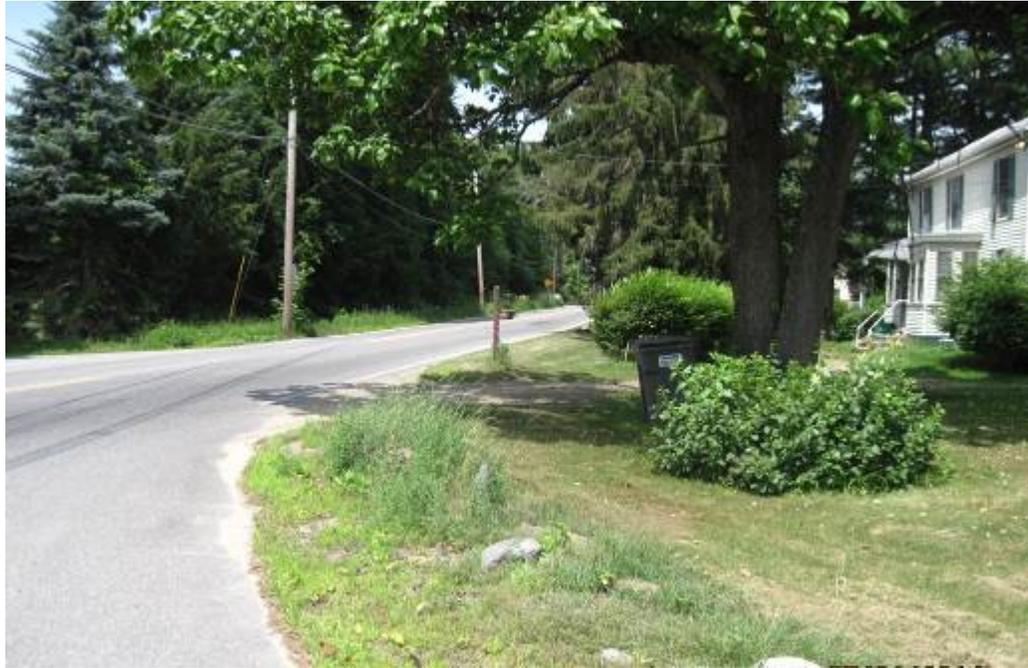
Harvard Rd. southbound approach looking west

- Harvard Rd. in Lancaster has insufficient stop control sight distance from southbound approach looking east/west and from the northbound approach looking east. Private bushes, trees, and fence reduce visibility at the intersection. Furthermore, drivers can expect a LOS of (F) in the PM peak hour entering Rte. 117 from the north and southbound Harvard Rd. approaches.
